LOWER ST CROIX RIVER

ORDINARY HIGH WATER MARK EVALUATION

FIELD SITE LOCATIONS

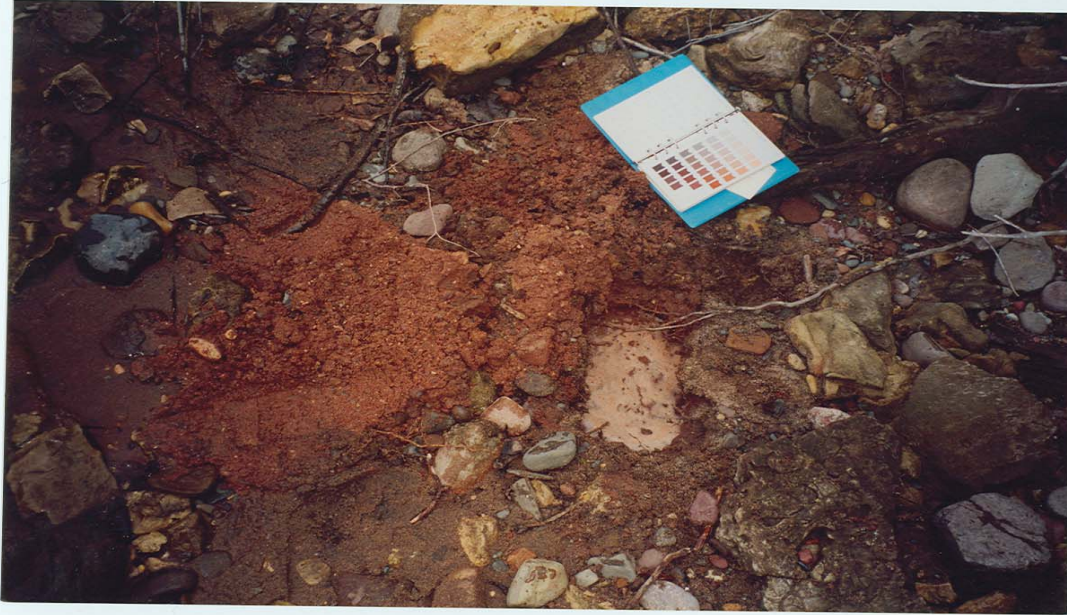
We could not sample soils at Bob Rolle's property due to presence of bedrock.

Soil samples at other sites were hydric soils in areas of other indicators; such as, exposed roots, water stains, or predominance of hydrophytic vegetation.

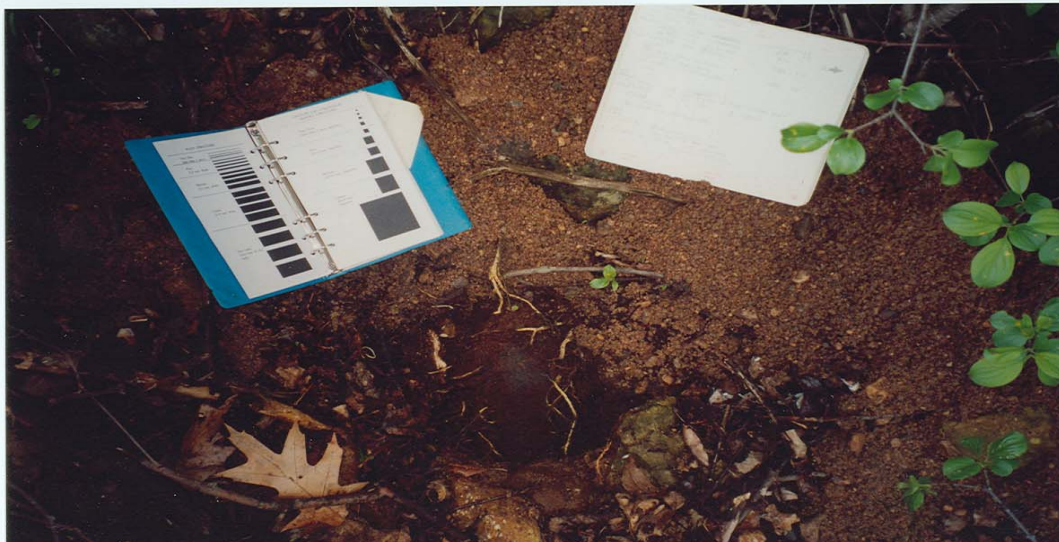
We documented presence of trees with exposed roots and trees without and their locations
